Solicitation Number
DACA21-03-R-0070
Ranger Barracks Complex
Volume IV of IV – Asbestos Reports
FY-04, Line Item 51127
November 2003

Asbestos Survey

**Building No. 1275 Hunter Army Air Field,
Georgia**

Asbestos Inspection Report

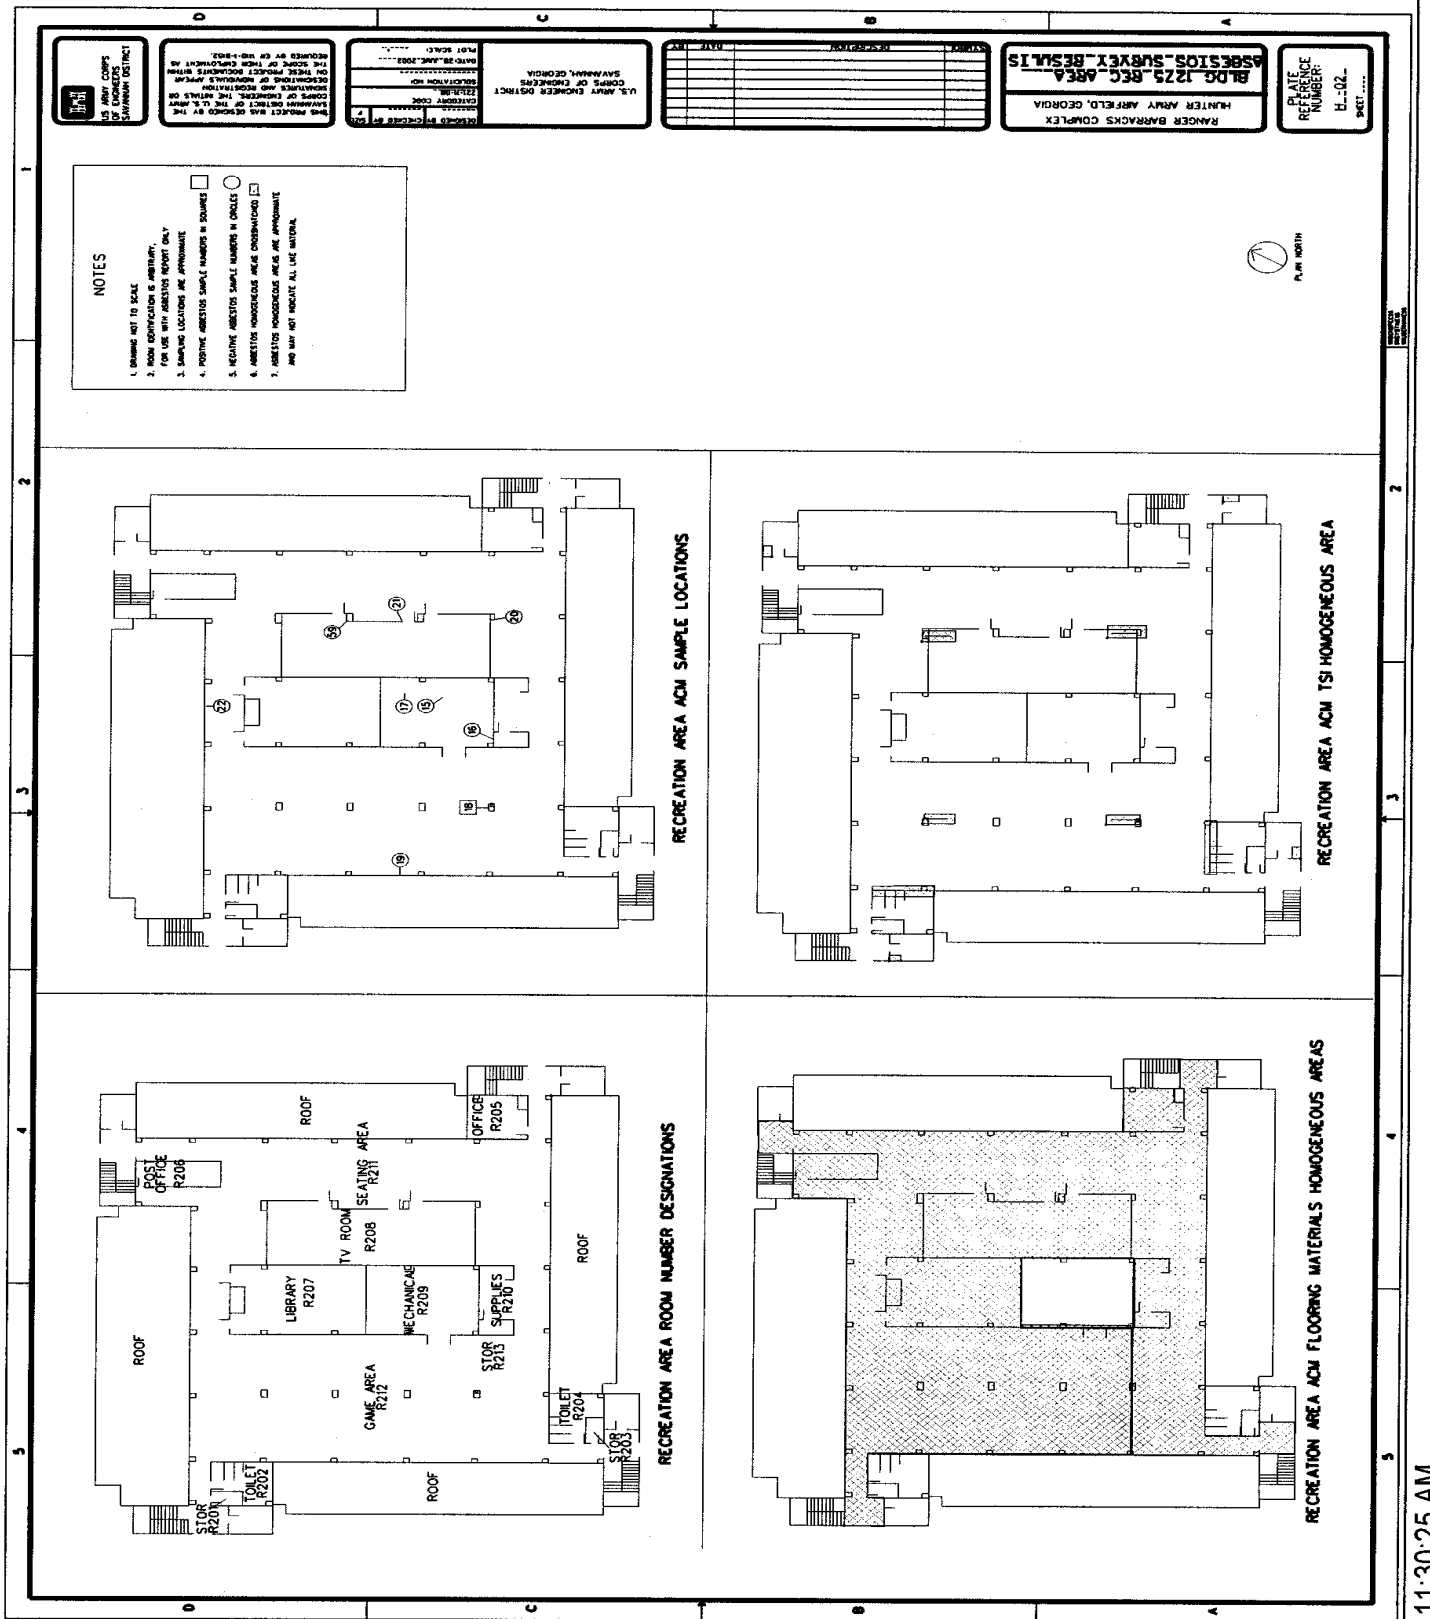
Figure 2

- a. *Silver Surfacing Material:* Silver brushed on surfacing material commonly referred to as “Cool Seal” located on the air handler and other structures installed on the Recreation Area roof contain asbestos- (Refer to Tables 1, 2 and 3 for specific information and Figures for sample locations and homogeneous area locations).
